In Their Final Flight: Honouring the Memory of The Fallen in the Z-9EH Tragedy

**A Forensic Reflection on Emergency Response
And the Dignity of National Loss**

Colonel Festus Aboagye (Retired)

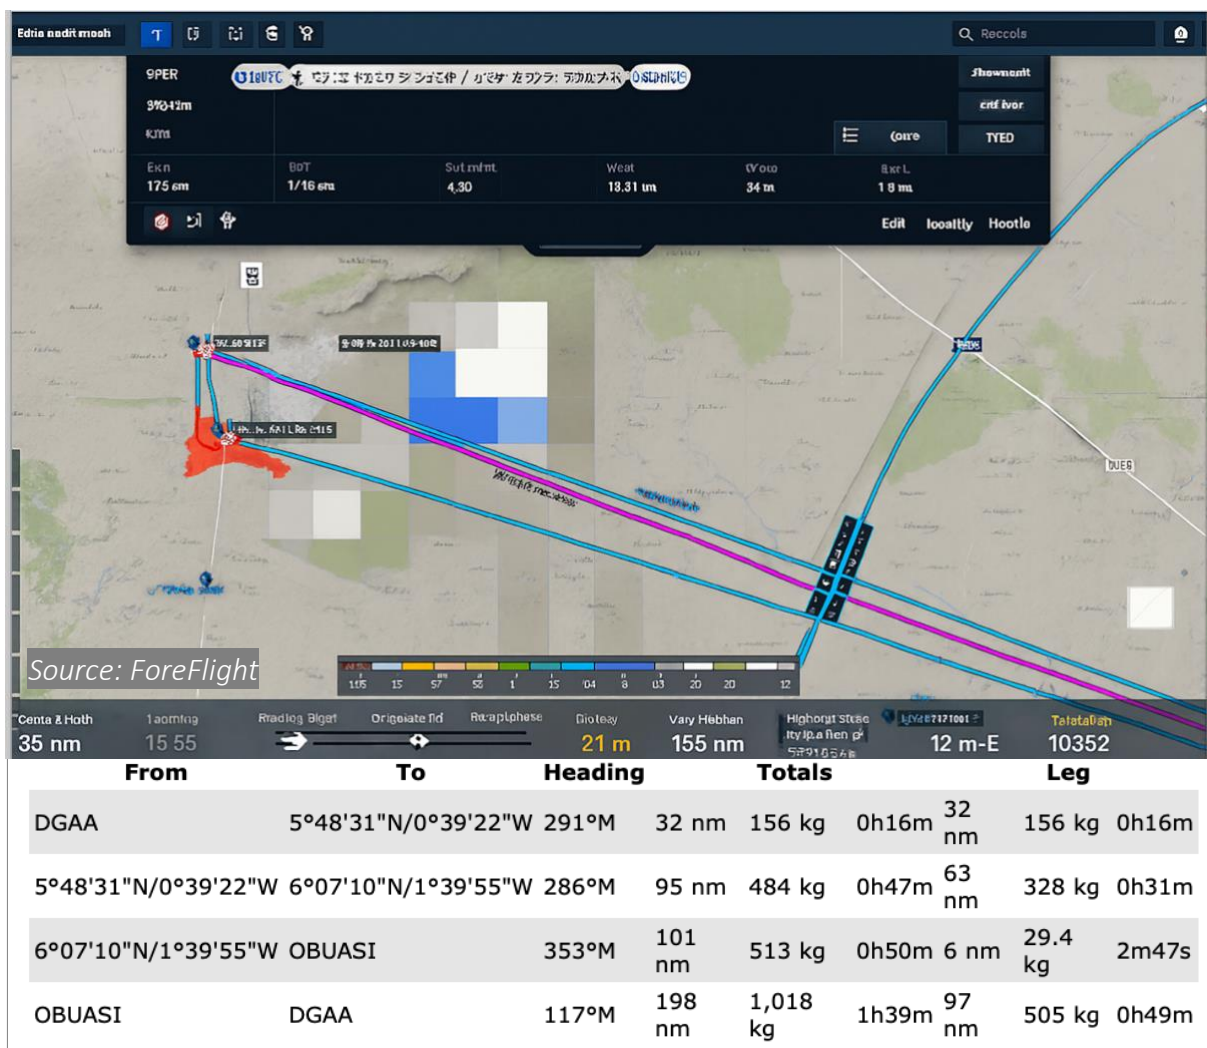
Figure 2: Estimated Flight Path of Z-9EH

According to alleged Air Traffic Control (ATC) reports, the aircraft disappeared from radar approximately 14 minutes after departure. It failed to arrive at its destination and was later confirmed to have crashed near Sikaman, in the vicinity of Adansi Akrofuom, Ashanti Region (see Figure 2).
