In Their Final Flight: Honouring the Memory of The Fallen in the Z-9EH Tragedy

**A Forensic Reflection on Emergency Response
And the Dignity of National Loss**

Colonel Festus Aboagye (Retired)

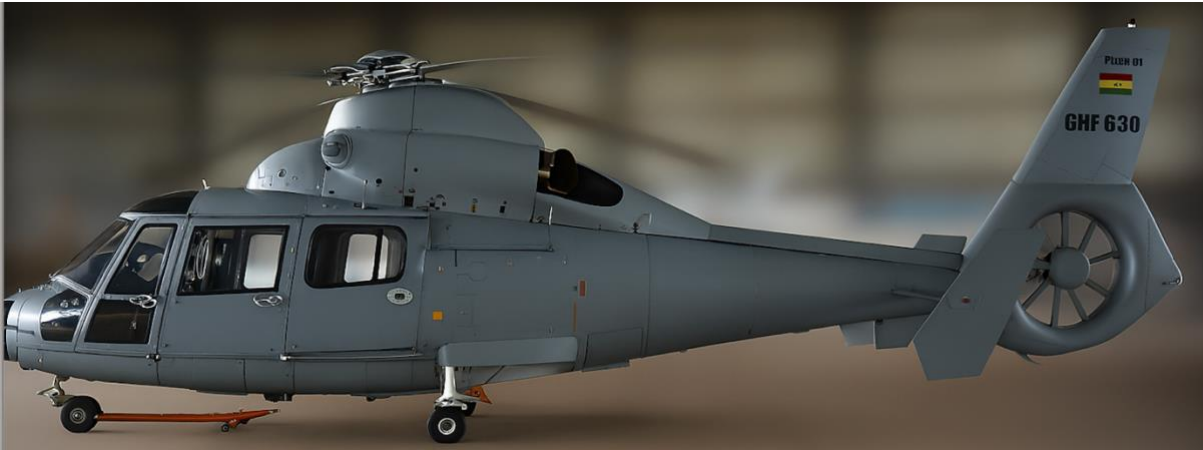
Photo: Z9-EH Helicopter GHF 632 (Source: AI-enhanced)

The Harbin Z-9EH is a license-built variant of the Eurocopter AS365 Dauphin. The Volta River Authority aviation flies a similar aircraft, adapted for military utility roles. Jane’s Defence Weekly (2023) notes that the Z-9EH features a composite rotor system and digital flight control enhancements but lacks terrain-following radar or crash-survivable flight data recorders.
